# AEROSPACE FIRM DETERMINES ROOT CAUSES OF BEARING FAILURE WITH ROBO-MET.3D®

### SKF AEROENGINE HAD A CHALLENGE

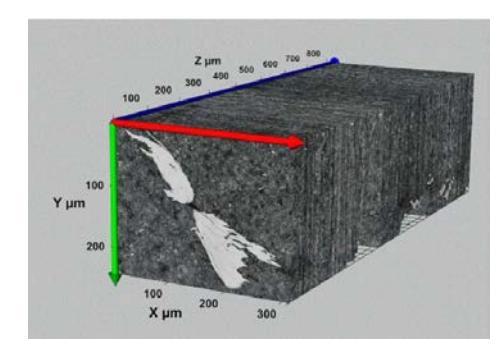
A stack of 150 serial sections of spalled M50 bearing collected by Robo-Met.3D®. A ceramic inclusion at the center of this formation was the cause of failure.

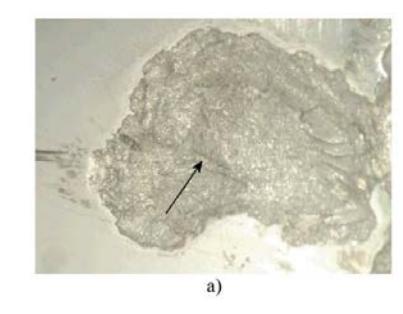
*Fig. 1a- Spalled area in VIM-VAR AISI M50 ball; 1b- mounted sample for serial sectioning.*

The spalled ball had a unique linear indication running parallel with the raw material grain flow. SKF suspected that there was an inclusion causing this. However, the inclusion material was lost when the samples were prepared using conventional 2D metallographic techniques.

SKF needed to present evidence to their material supplier that the bearing failures were caused by subsurface inclusions. One ball was selected for serial sectioning analysis using Robo-Met.3D®, having a spall with a linear indication that went subsurface (Fig. 1a).

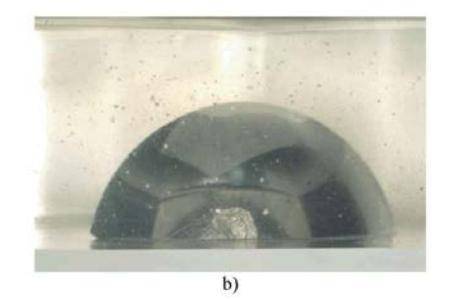
SKF's sample was mounted for metallography. Knowing the orientation of the linear indication allowed the sample to be mounted with the feature ideally positioned for serial sectioning (Fig. 1b). The sample was polished

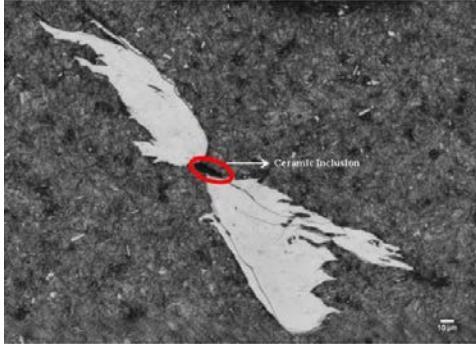
*Fig. 2a- Typical 2D optical micrograph of butterfly and initiating inclusion.*

An inclusion was identified in the butterfly formation (Fig. 2a). Segmentation helped to isolate and identify the nonmetallic inclusion in the spalled ball. The inclusion proved to be sizable, and extended through the butterfly region (Figs. 3a, b). The feature was traced for over 400  $\mu$ m. The elongated morphology matches two classifications as defined by ASTM E45, Type A-Sulfides and Type C-Silicates. This provided the required evidence.

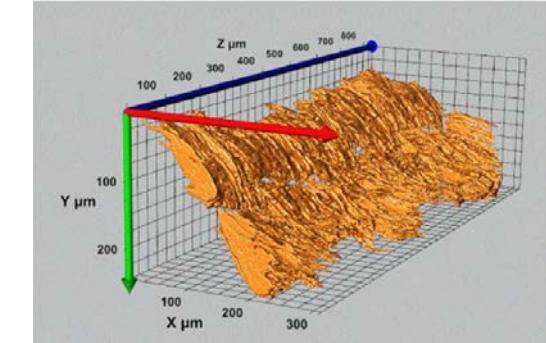
About 150 sections, or slices of data were collected for this sample, at an average separation of 5.6  $\mu$ m. Imaging was performed using a 50× objective and 1× optivar. The resultant spatial resolution is approximately 0.21  $\mu$  in both x and y. The 2D image tiles from each layer were stitched into 2× 2 montages, and registered with the images from the next layer using Fiji and Image Pro Premier software suites. The reconstructed data set had dimensions of 300  $\mu$ m ×300  $\mu$ m ×840  $\mu$ m along length, width and depth. Fig. 2a is a 2D image, and 2b is an image of the segmented butterfly feature in 3D.

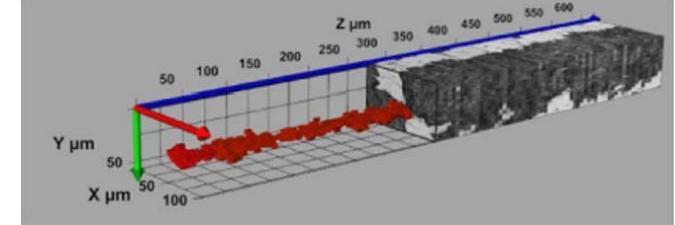
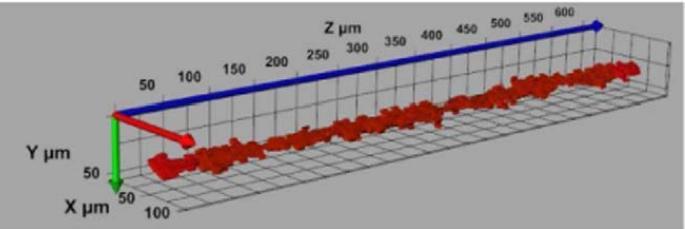
The Robo-Met.3D system produces a comprehensive scale of analysis that is orders of magnitude larger than is practical in FIB/SEM serial sectioning experiments. The technique was useful for investigating a failed component from the field and determining the root cause. Due to the large sampling volume, a butterfly feature formed on an elongated inclusion was traced for over 500  $\mu$ m, achieving the study objective.
