146th Annual Meeting & Exhibition

# The Use of Laser Ultrasound to Detect Defects in Laser Melted Parts

Sarah Everton, Phill Dickens, Chris Tuck, Ben Dutton  
and David Wimpenny

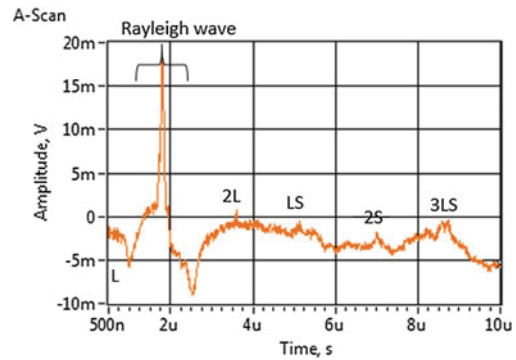
**Fig. 2** A typical A-scan, extracted from LaserScan with surface displacements from wave arrivals indicated, for a defect-free sample

Ultrasonic data is typically displayed in two ways: firstly, an A-scan is produced at each scanning location, which displays the received ultrasonic energy at the detection point, as a function of time (Fig. 2). The Rayleigh wave's comparatively large amplitude makes it easier to analyse.

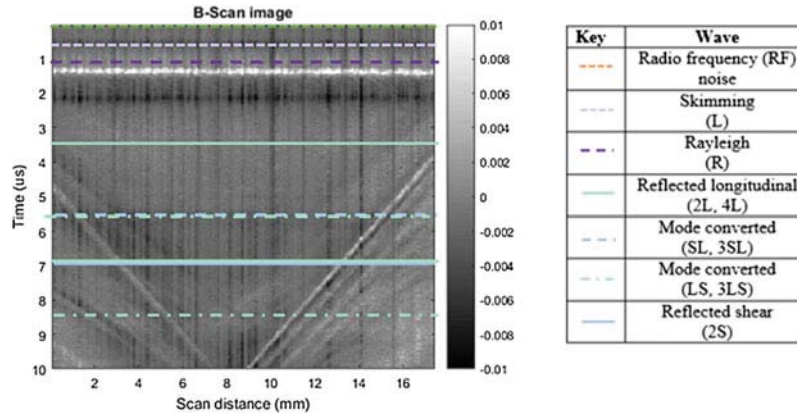
**Fig. 3** Predicted wave arrival times overlaid on a B-scan for a defect-free sample, with key

Secondly, a motorised stage is used to move the lasers along and a snapshot is taken at defined distance intervals along the top of the sample. The series of A-scans are then compiled and stacked to create a profile view of the sample, termed a B-scan (Fig. 3). The expected arrival times for each wave and mode-converted wave type are overlaid. The diagonal lines that can be seen are

reflections from the end walls of the sample, as the laser unit moves farther from one end, the time for the wave to travel to the detection point increases. Similarly, the laser unit moves towards the other end of the sample and the wave travel time decreases.

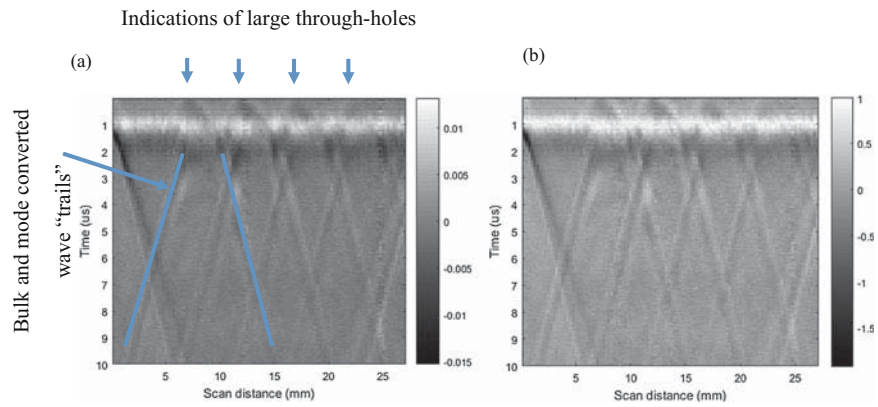
**Fig. 6** Scanning line 1 B-scans showing amplitude variation (mV) and elapsed time **a** filtered and **b** filtered and scaled

The samples were scanned along three scanning lines indicated in Fig. 5 and a B-scan generated for each dataset (Figs. 6, 7 and 8). The data has been processed to eliminate the laser shot noise, reduce background noise and to remove the DC offset, then scaled by the maximum signal amplitude to allow a direct comparison between B-scans to be made.

The four large through-holes are indicated by four 'triangles' in the above B-scans, peaking at roughly 7, 12, 17 and 22 mm scan distance. The reflected and mode-converted waves appear as "trails" after the arrival of the Rayleigh wave

which arrives at approximately 1  $\mu\text{s}$ . No further defects are indicated. The B-scans generated from different scanning lines can be directly compared, highlighting any changes in wave arrival times. Very small changes are seen in the arrival time of the Rayleigh and reflected shear waves from scan to scan; this is thought to be due to the geometry of the sample.
